**NIST NCSTAR 1-5A** Federal Building and Fire Safety Investigation of the World Trade Center Disaster

## Visual Evidence, Damage Estimates, **And Timeline Analysis**

(Appendices D-G)

## Appendix D WTC 1 EAST FACE COMBINED FIRE AND WINDOW CONDITION AND WINDOW SMOKE CONDITION

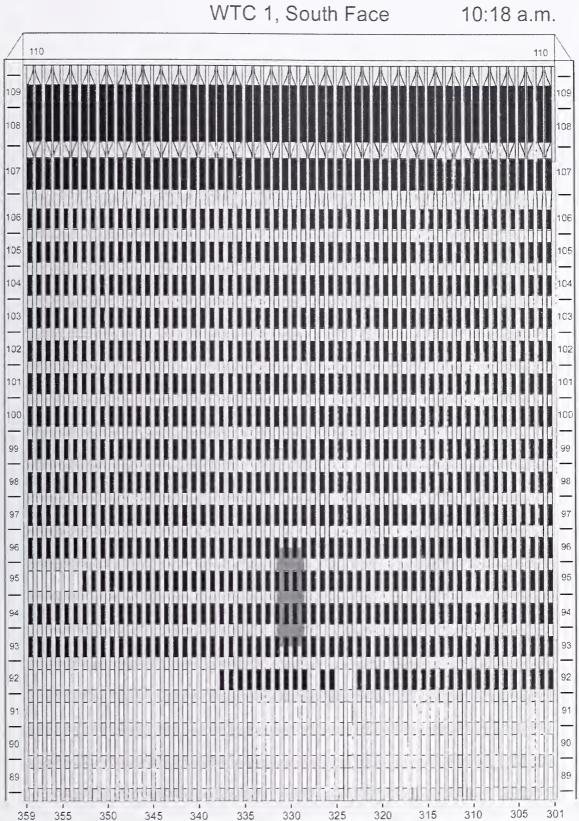
Figure E-46. Diagram of the south face of WTC 1 for floors 89 to 110 at 10:18 a.m. showing windows where smoke was observed and those that were hidden from view.

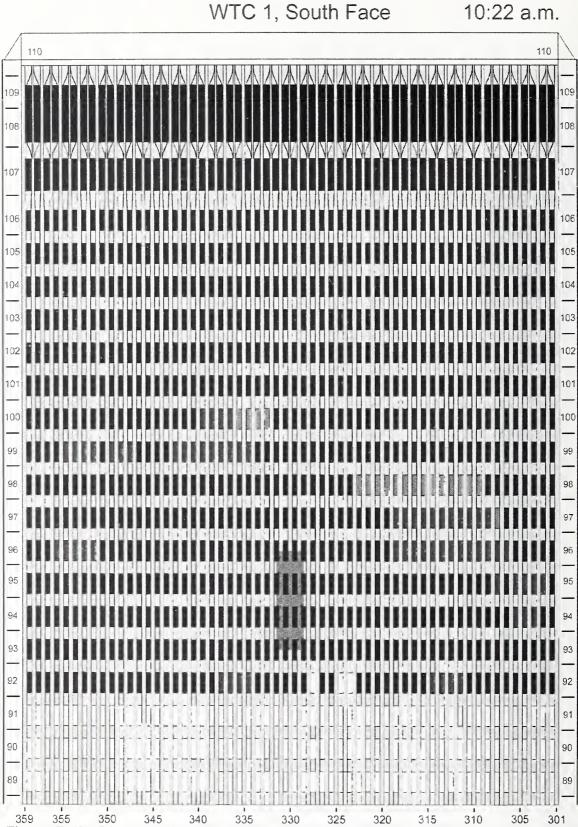
Figure E-47. Diagram of the south face of WTC 1 for floors 89 to 110 at 10:22 a.m. showing the condition of windows and locations of fires.

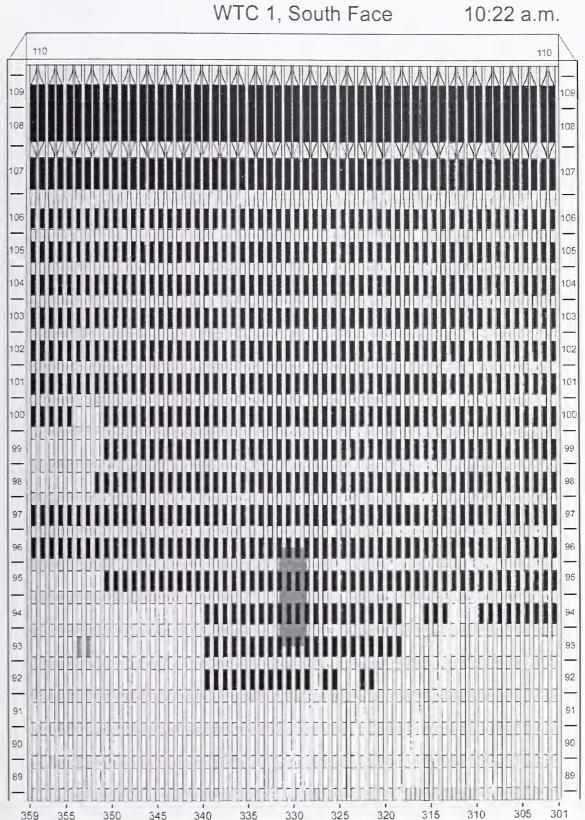
Figure E- 48. Diagram of the south face of WTC 1 for floors 89 to 110 at 10:22 a.m. showing windows where smoke was observed and those that were hidden from view.

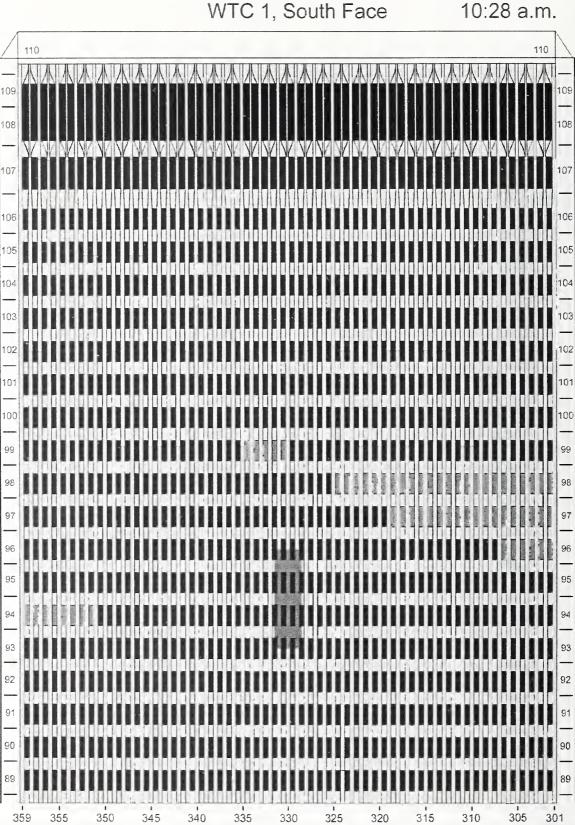
Figure E-49. Diagram of the south face of WTC 1 for floors 89 to 110 at 10:28 a.m. showing the condition of windows and locations of fires.

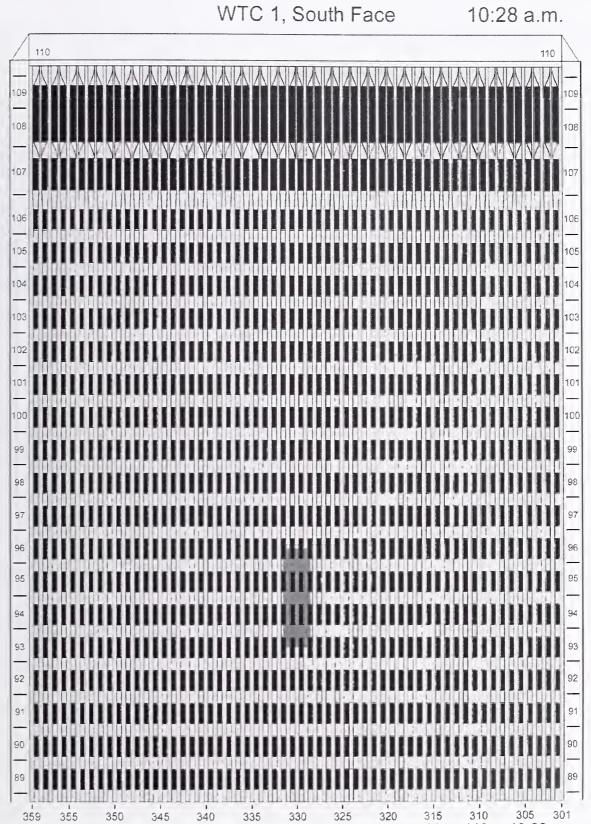
Figure E-50. Diagram of the south face of WTC 1 for floors 89 to 110 at 10:28 a.m. showing windows where smoke was observed and those that were hidden from view.

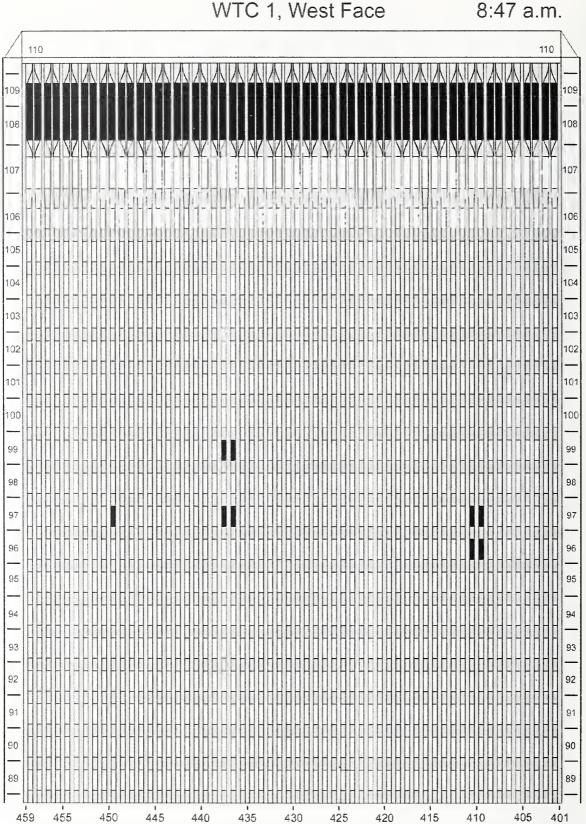
Figure F-1. Diagram of the west face of WTC 1 for floors 89 to 110 at 8:47 a.m. showing the condition of windows and locations of fires.

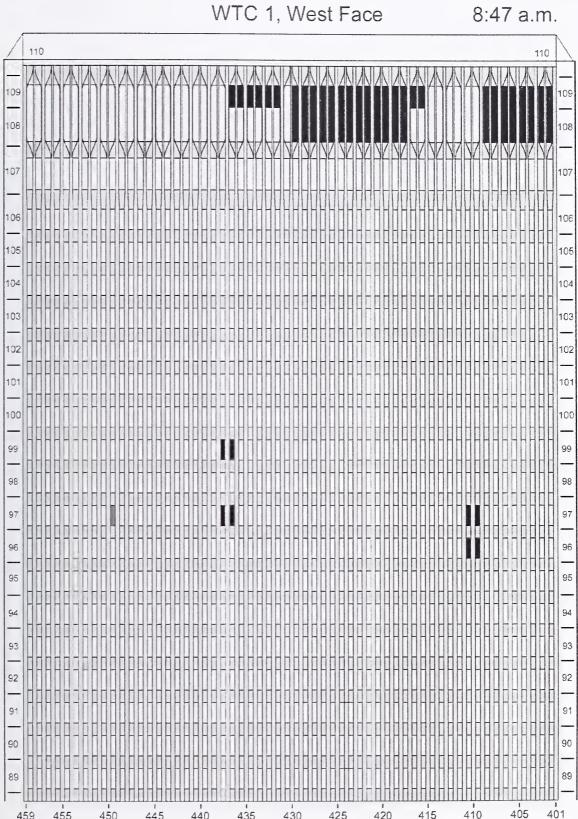
Figure F-2. Diagram of the west face of WTC 1 for floors 89 to 110 at 8:47 a.m. showing windows where smoke was observed and those that were hidden from view.

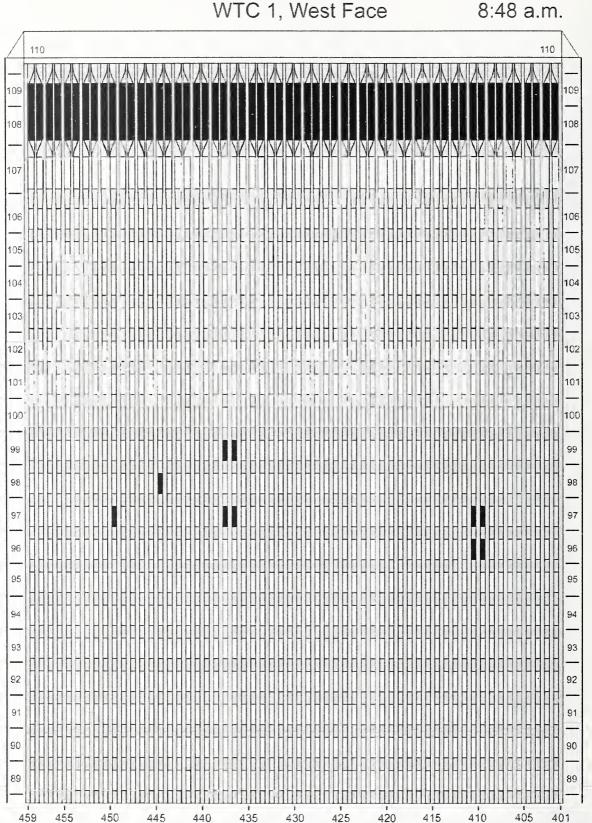
Figure F-3. Diagram of the west face of WTC 1 for floors 89 to 110 at 8:48 a.m. showing the condition of windows and locations of fires.

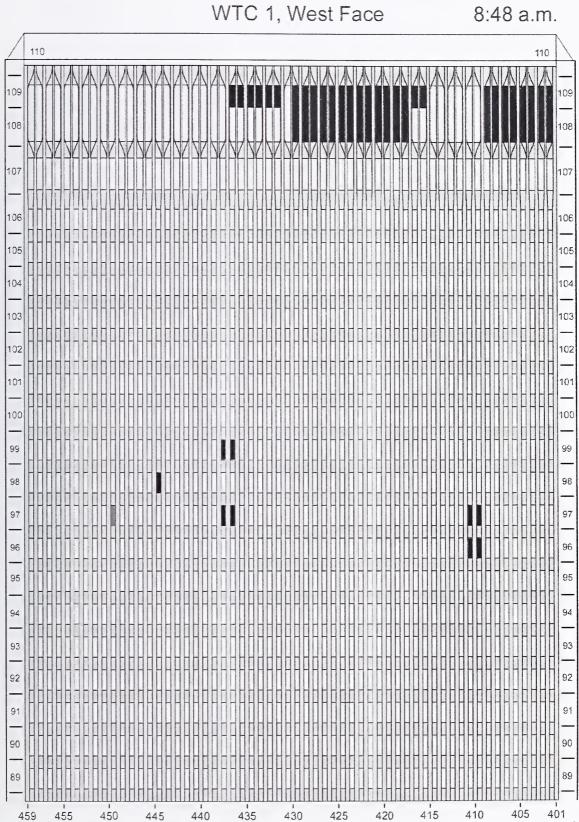
Figure F-4. Diagram of the west face of WTC 1 for floors 89 to 110 at 8:48 a.m. showing windows where smoke was observed and those that were hidden from view.

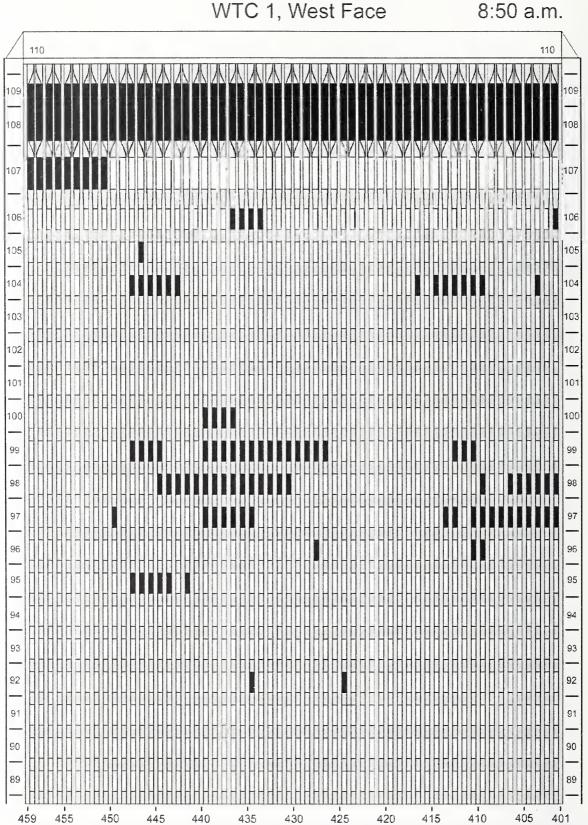
Figure F-5. Diagram of the west face of WTC 1 for floors 89 to 110 at 8:50 a.m. showing the condition of windows and locations of fires.

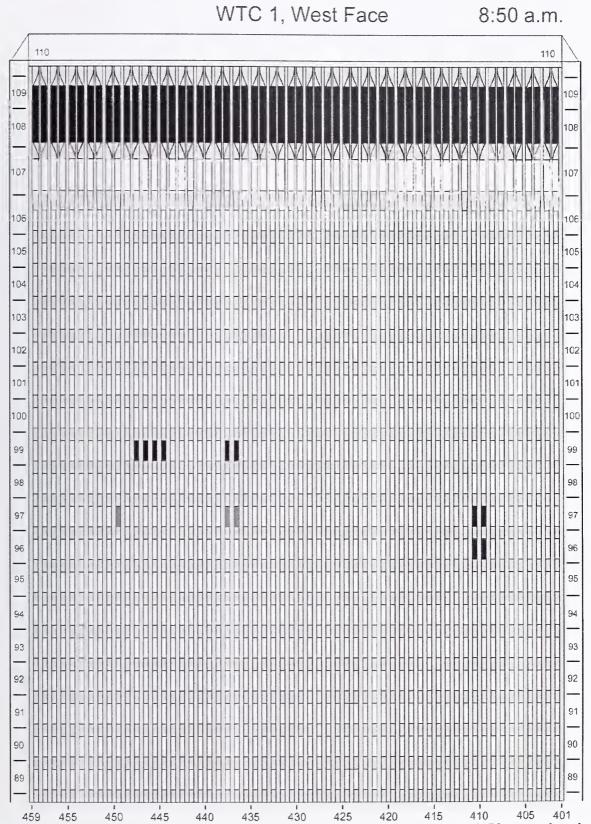
Figure F-6. Diagram of the west face of WTC 1 for floors 89 to 110 at 8:50 a.m. showing windows where smoke was observed and those that were hidden from view.

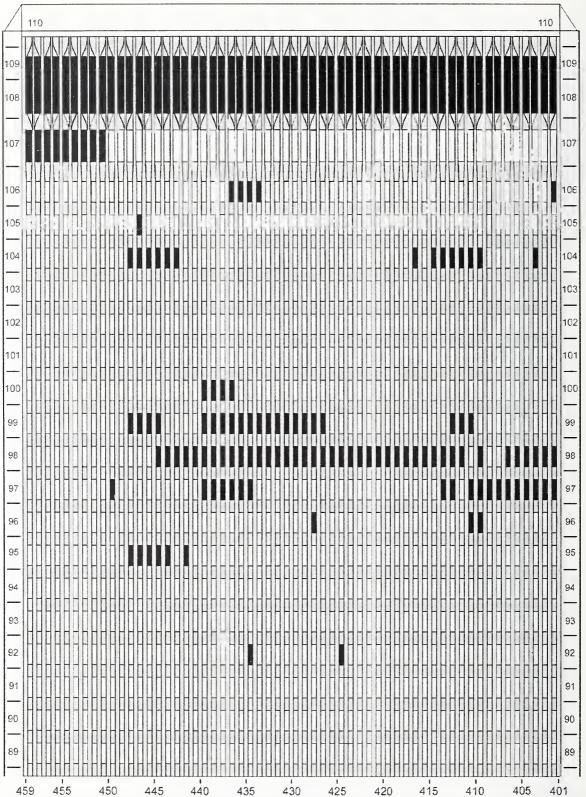
Figure F-7. Diagram of the west face of WTC 1 for floors 89 to 110 at 8:52 a.m. showing the condition of windows and locations of fires.

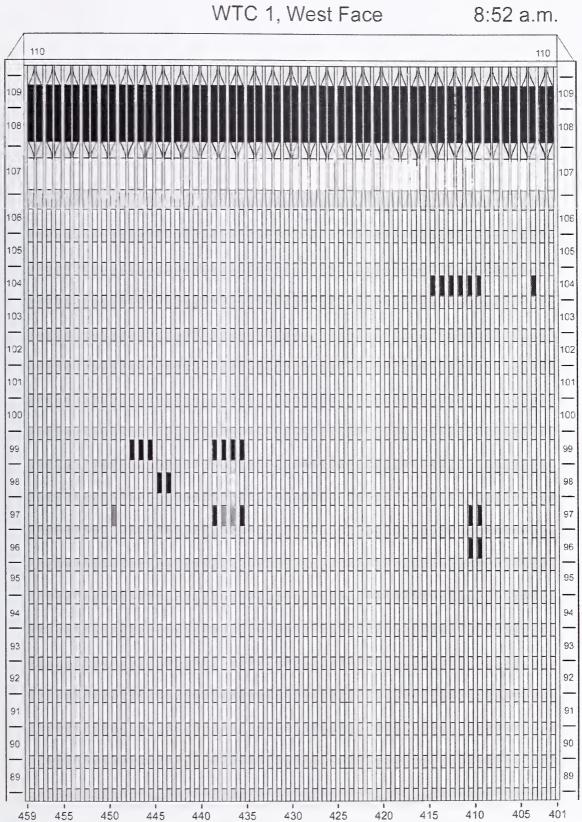
Figure F-8. Diagram of the west face of WTC 1 for floors 89 to 110 at 8:52 a.m. showing windows where smoke was observed and those that were hidden from view.

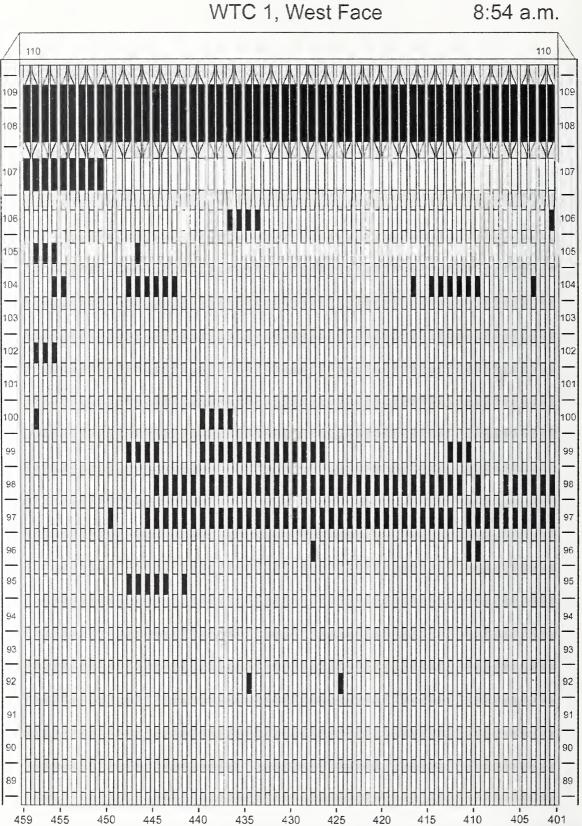
Figure F-9. Diagram of the west face of WTC 1 for floors 89 to 110 at 8:54 a.m. showing the condition of windows and locations of fires.

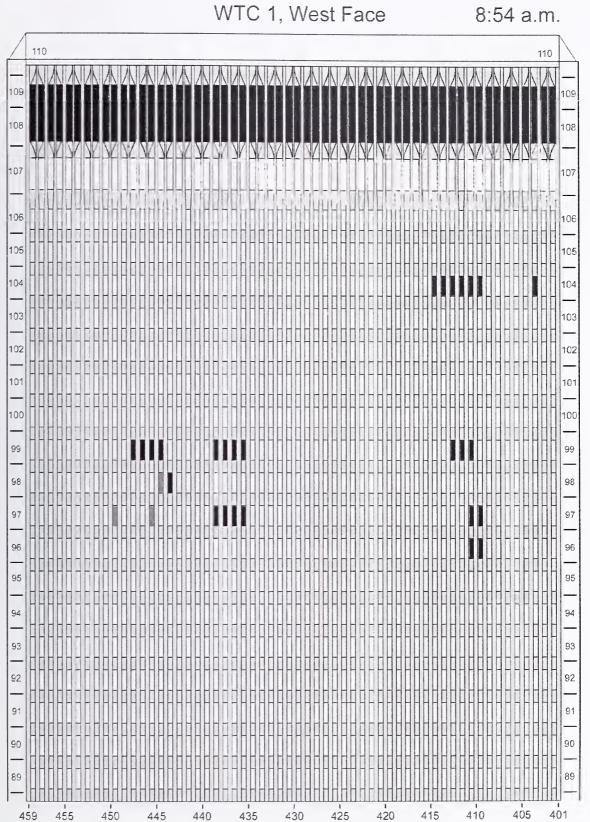
Figure F-10. Diagram of the west face of WTC 1 for floors 89 to 110 at 8:54 a.m. showing windows where smoke was observed and those that were hidden from view.

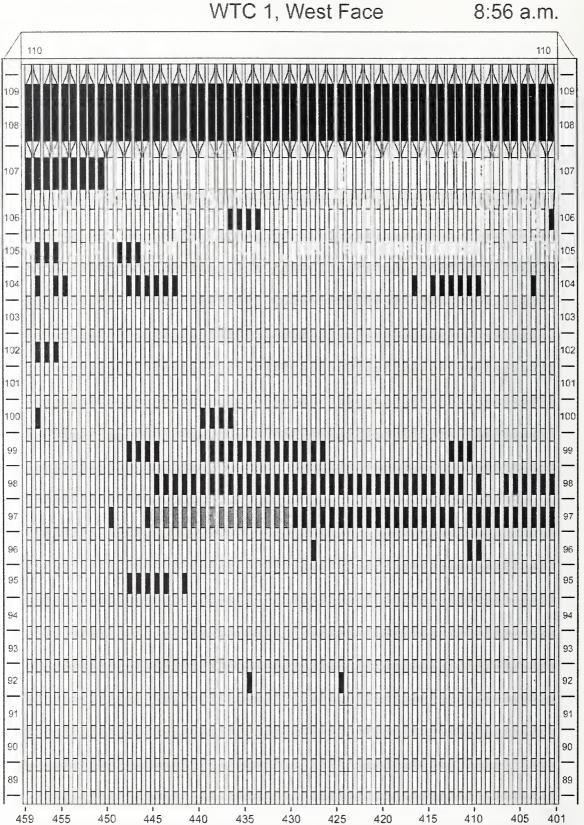
Figure F-11. Diagram of the west face of WTC 1 for floors 89 to 110 at 8:56 a.m showing the condition of windows and locations of fires.

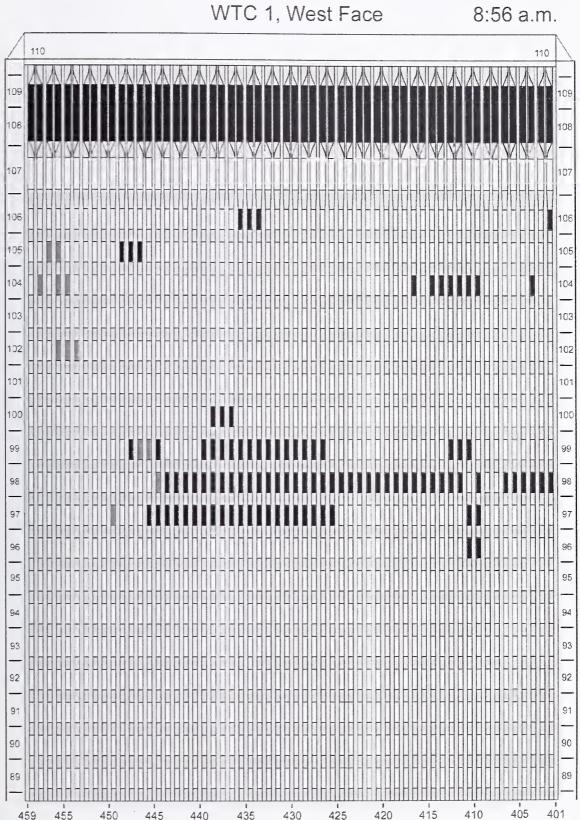
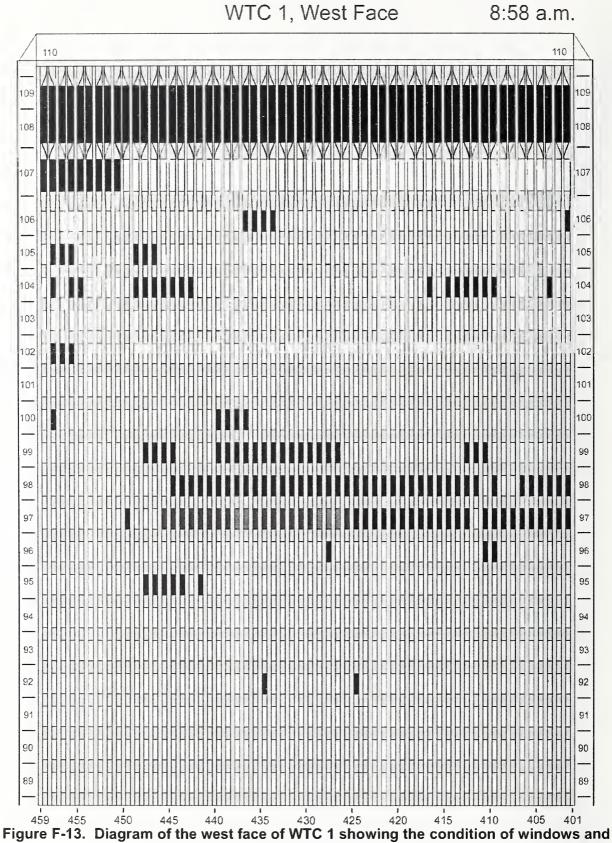
Figure F-12. Diagram of the west face of WTC 1 for floors 89 to 110 at 8:56 a.m. showing windows where smoke was observed and those that were hidden from view.

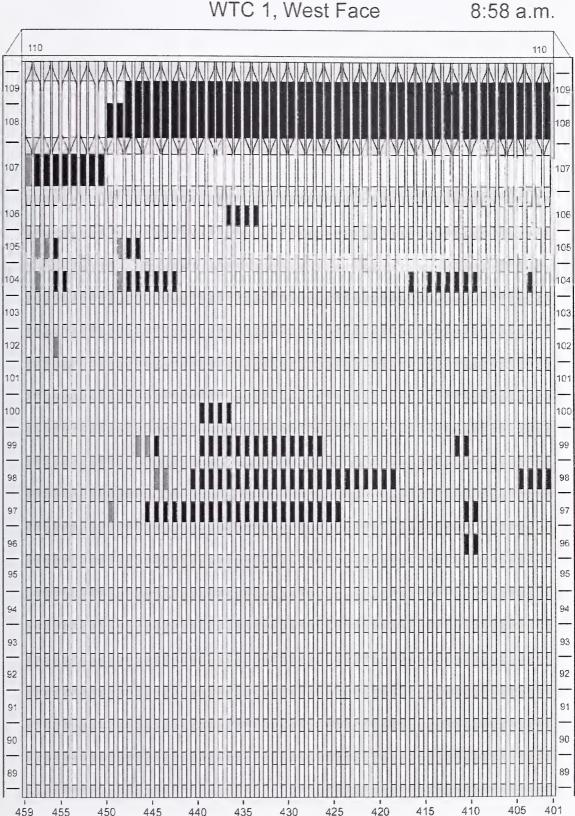
Figure F-14. Diagram of the west face of WTC 1 for floors 89 to 110 at 8:58 a.m. showing windows where smoke was observed and those that were hidden from view.

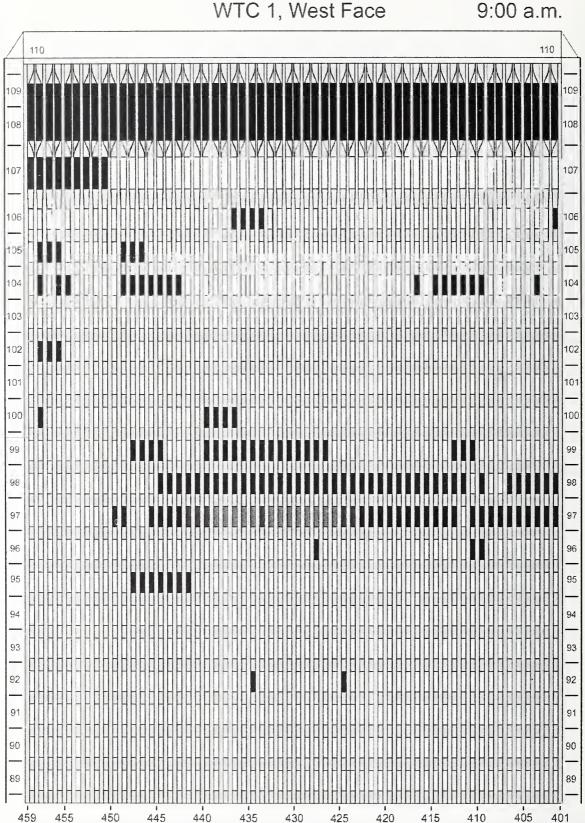
Figure F-15. Diagram of the west face of WTC 1 for floors 89 to 110 at 9:00 a.m. showing the condition of windows and locations of fires.

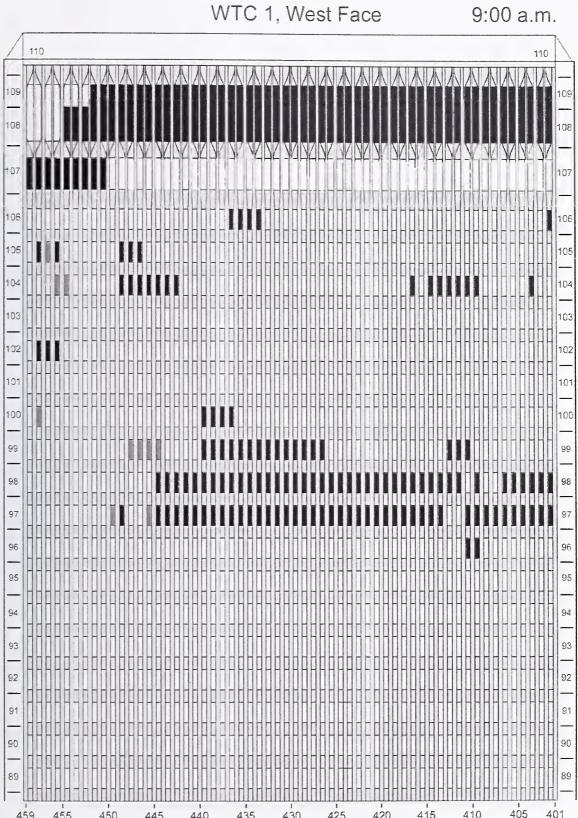
Figure F-16. Diagram of the west face of WTC 1 for floors 89 to 110 at 9:00 a.m. showing windows where smoke was observed and those that were hidden from view.

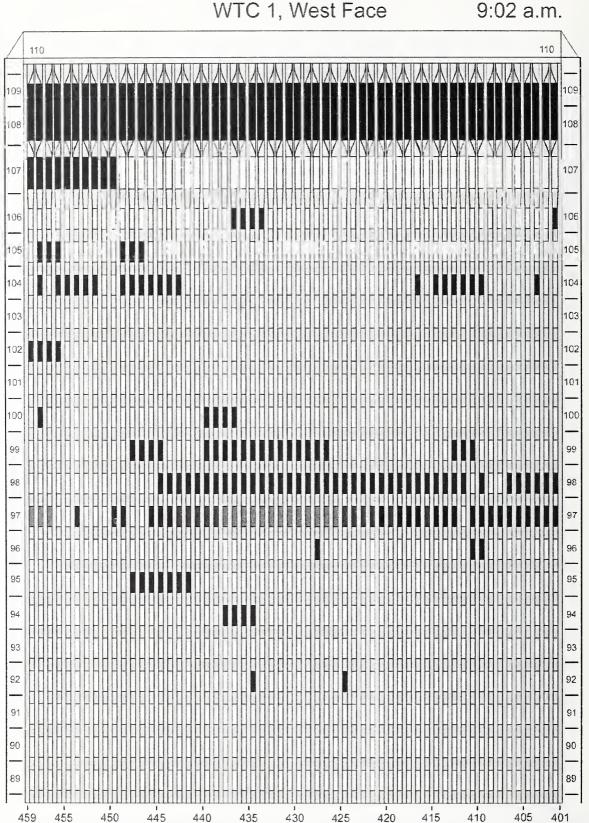
Figure F-17. Diagram of the west face of WTC 1 for floors 89 to 110 at 9:02 a.m. showing the condition of windows and locations of fires.

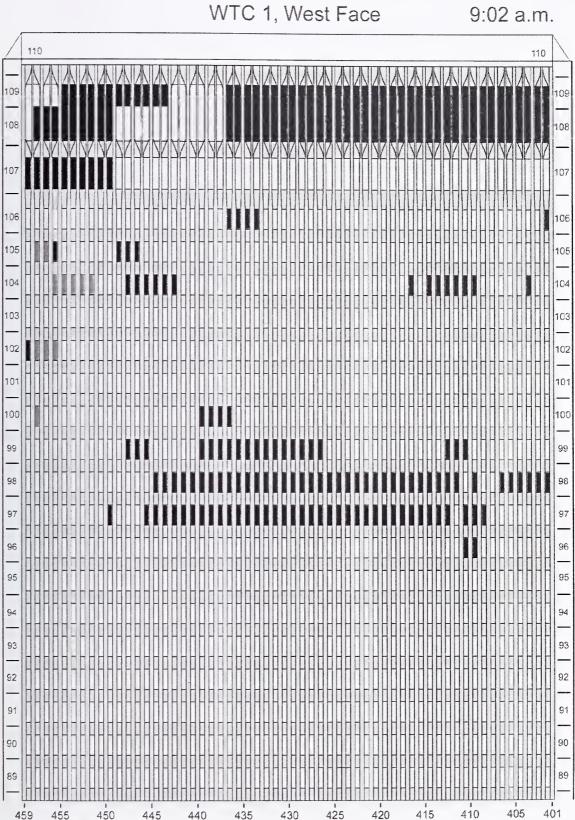
Figure F-18. Diagram of the west face of WTC 1 for floors 89 to 110 at 9:02 a.m. showing windows where smoke was observed and those that were hidden from view.

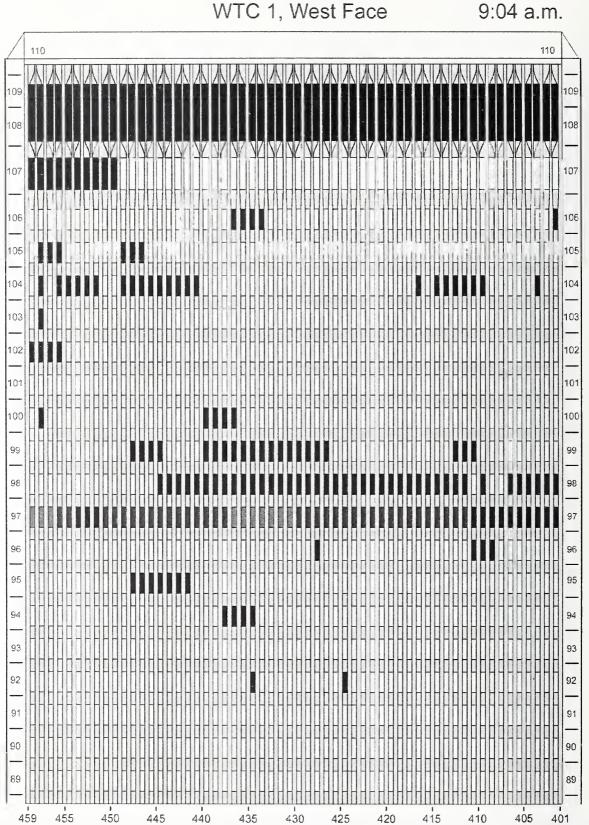
Figure F-19. Diagram of the west face of WTC 1 for floors 89 to 110 at 9:04 a.m. showing the condition of windows and locations of fires.

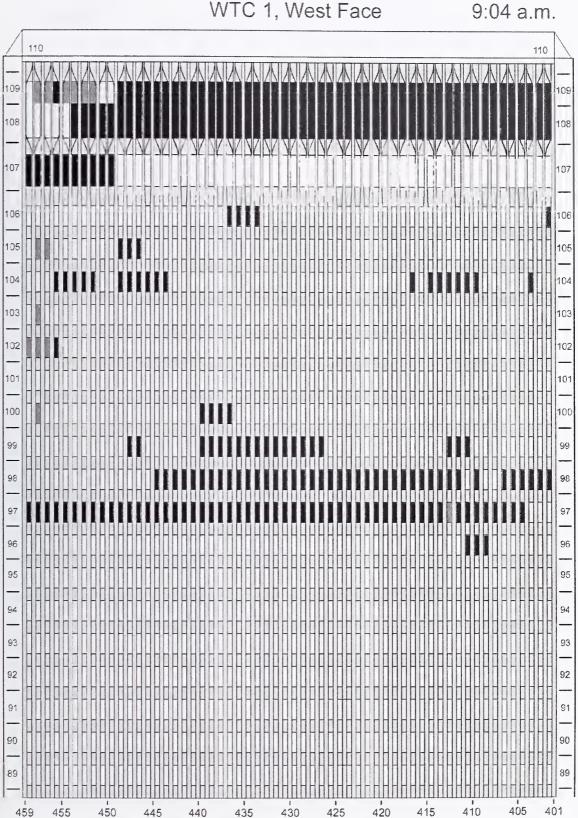
Figure F-20. Diagram of the west face of WTC 1 for floors 89 to 110 at 9:04 a.m. showing windows where smoke was observed and those that were hidden from view.

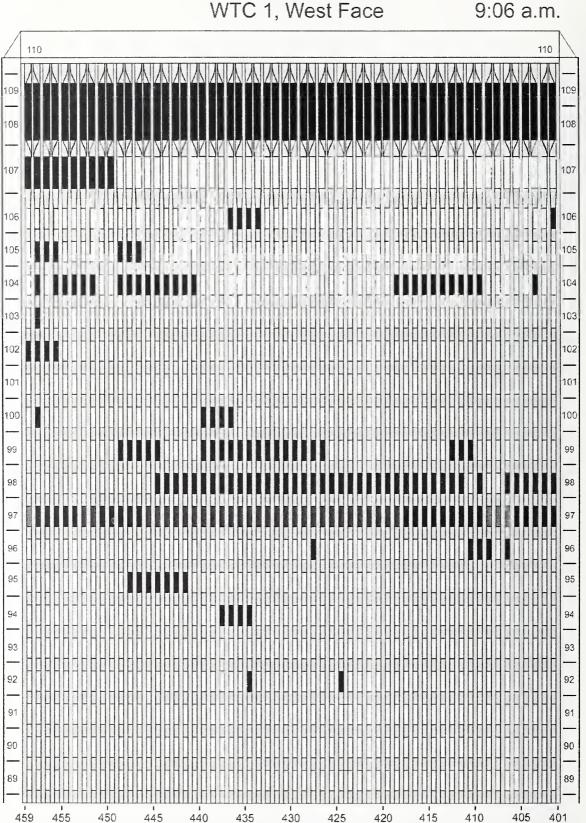
Figure F-21. Diagram of the west face of WTC 1 for floors 89 to 110 at 9:06 a.m. showing the condition of windows and locations of fires.

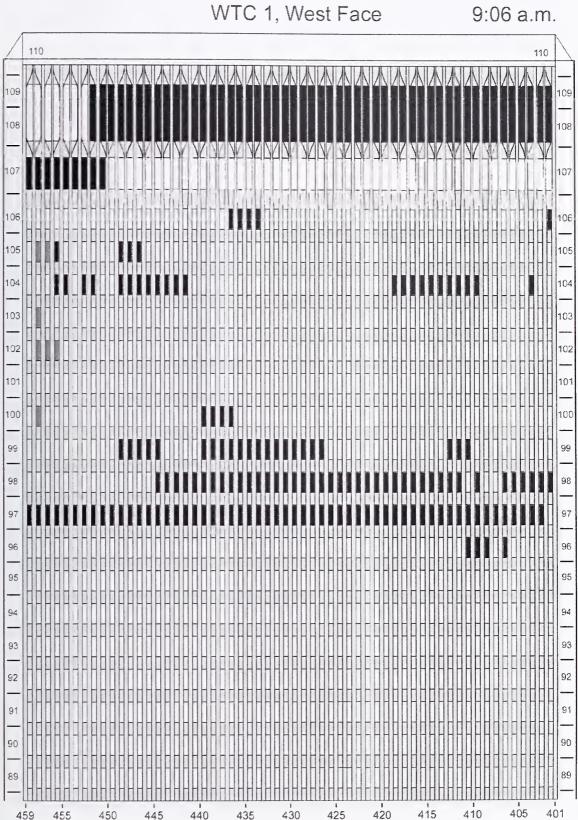
Figure F-22. Diagram of the west face of WTC 1 for floors 89 to 110 at 9:06 a.m. showing windows where smoke was observed and those that were hidden from view.

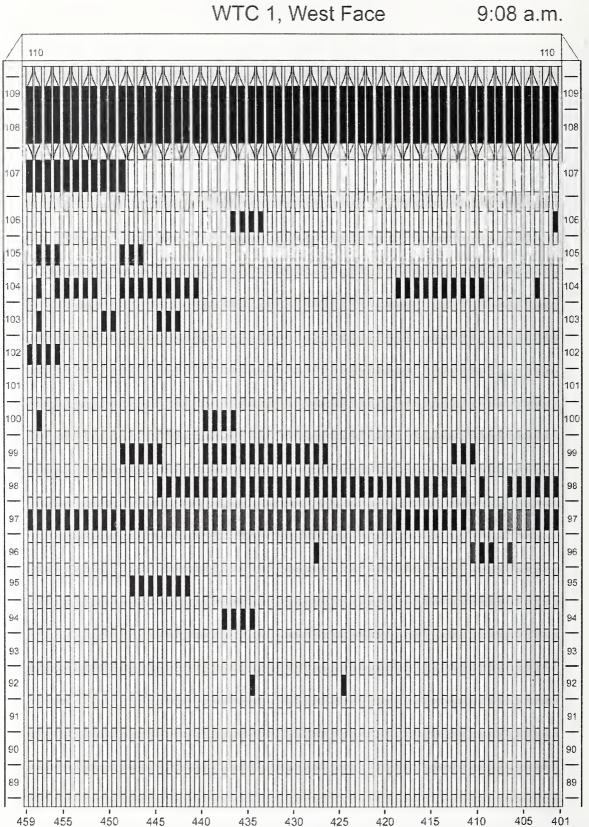
Figure F-23. Diagram of the west face of WTC 1 for floors 89 to 110 at 9:08 a.m. showing the condition of windows and locations of fires.

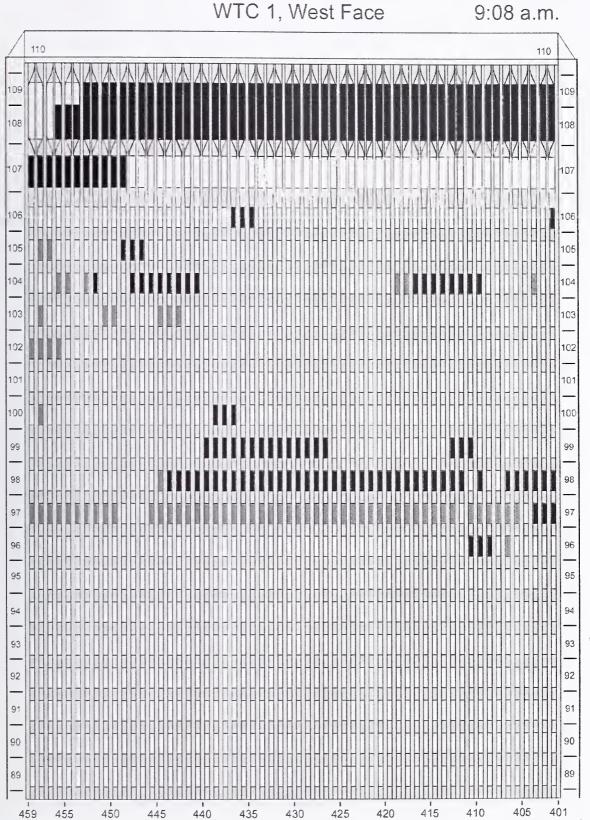
Figure F-24. Diagram of the west face of WTC 1 for floors 89 to 110 at 9:08 a.m. showing windows where smoke was observed and those that were hidden from view.

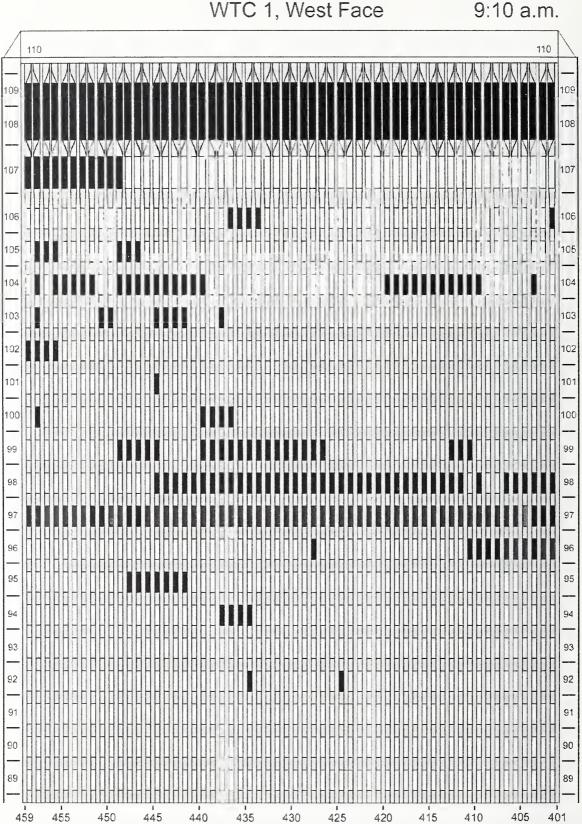
Figure F-25. Diagram of the west face of WTC 1 for floors 89 to 110 at 9:10 a.m. showing the condition of windows and locations of fires.

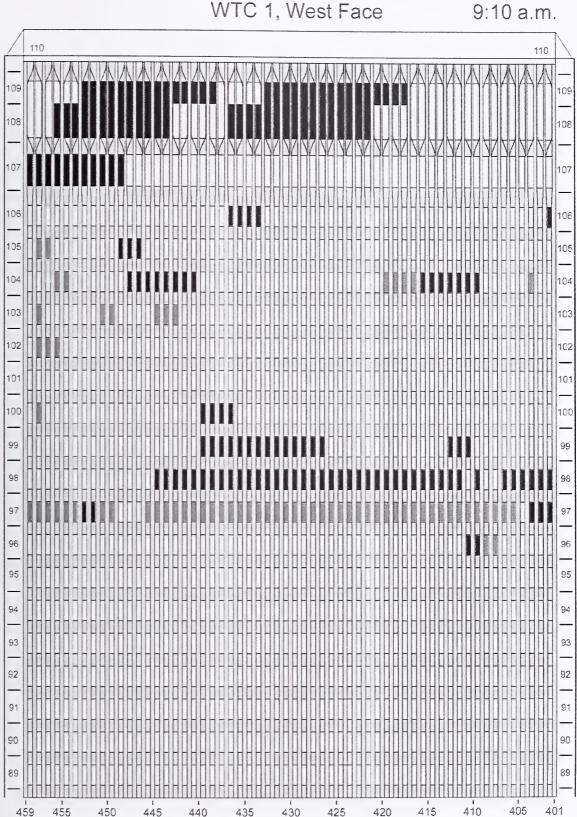
Figure F-26. Diagram of the west face of WTC 1 for floors 89 to 110 at 9:10 a.m. showing windows where smoke was observed and those that were hidden from view.

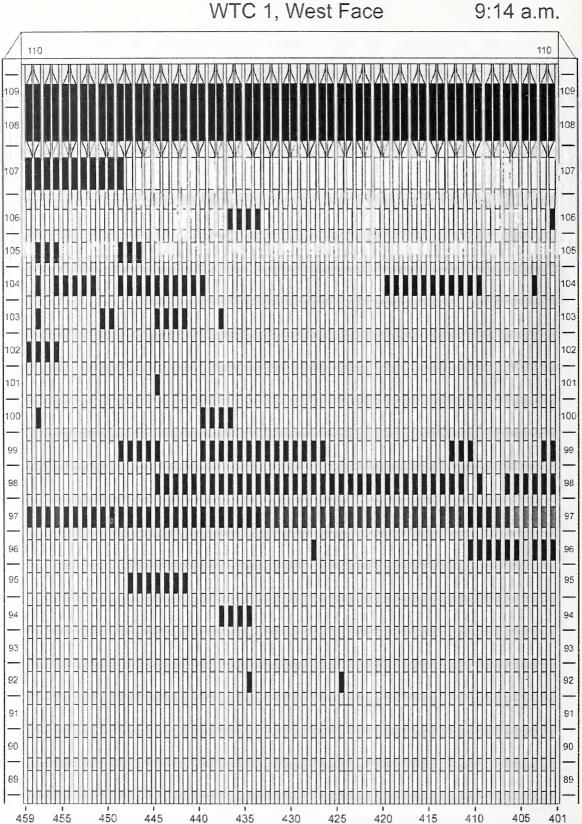
Figure F-27. Diagram of the west face of WTC 1 for floors 89 to 110 at 9:14 a.m. showing the condition of windows and locations of fires.

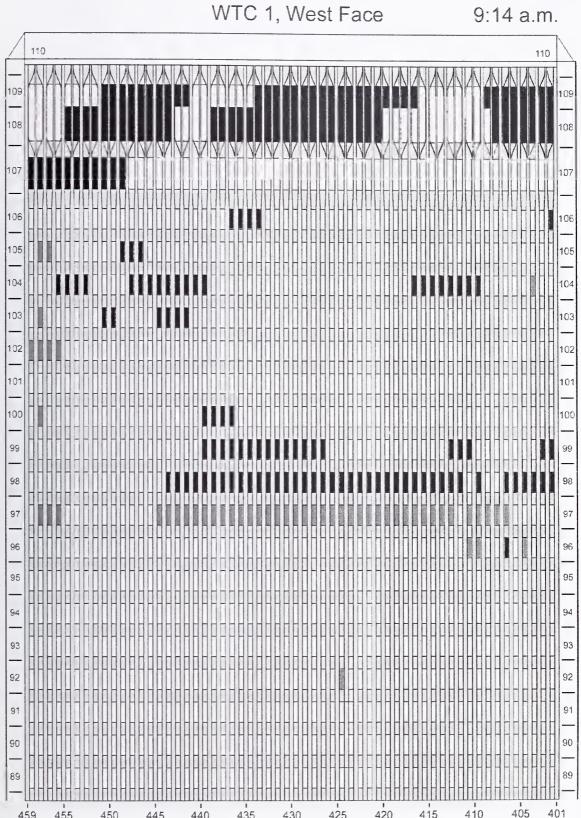
Figure F-28. Diagram of the west face of WTC 1 for floors 89 to 110 at 9:14 a.m. showing windows where smoke was observed and those that were hidden from view.

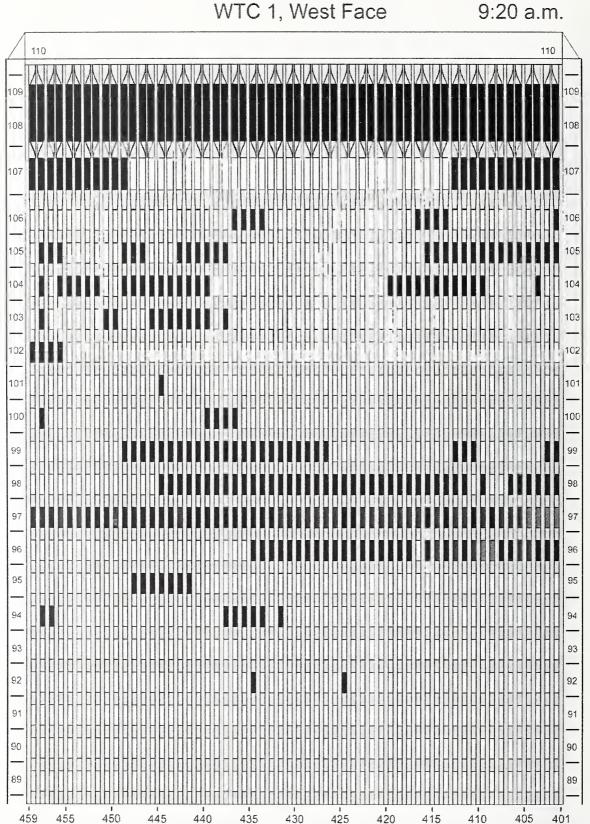
Figure F-29. Diagram of the west face of WTC 1 for floors 89 to 110 at 9:20 a.m. showing the condition of windows and locations of fires.

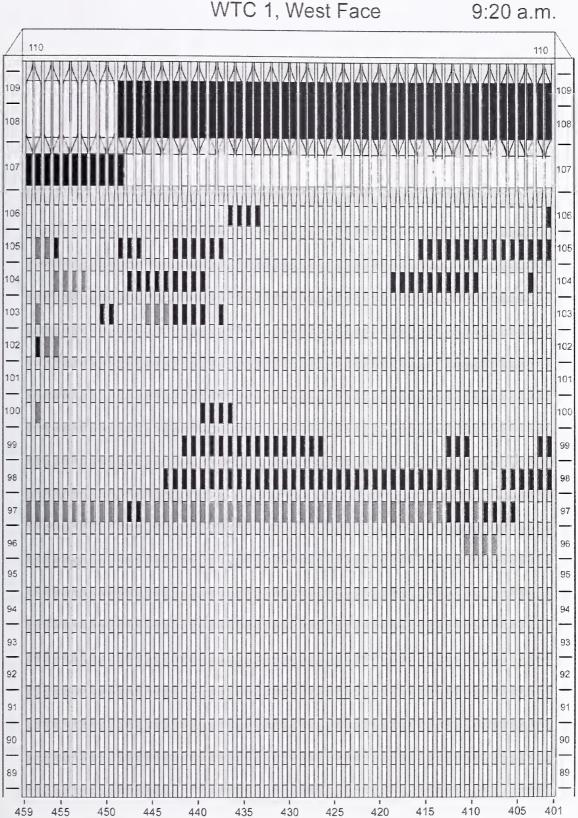
Figure F-30. Diagram of the west face of WTC 1 for floors 89 to 110 at 9:20 a.m. showing windows where smoke was observed and those that were hidden from view.

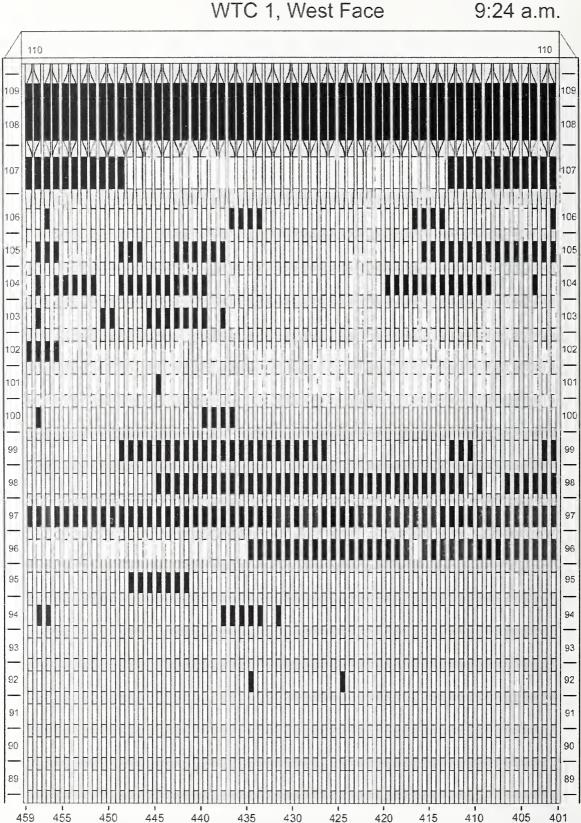
Figure F-31. Diagram of the west face of WTC 1 for floors 89 to 110 at 9:24 a.m. showing the condition of windows and locations of fires.

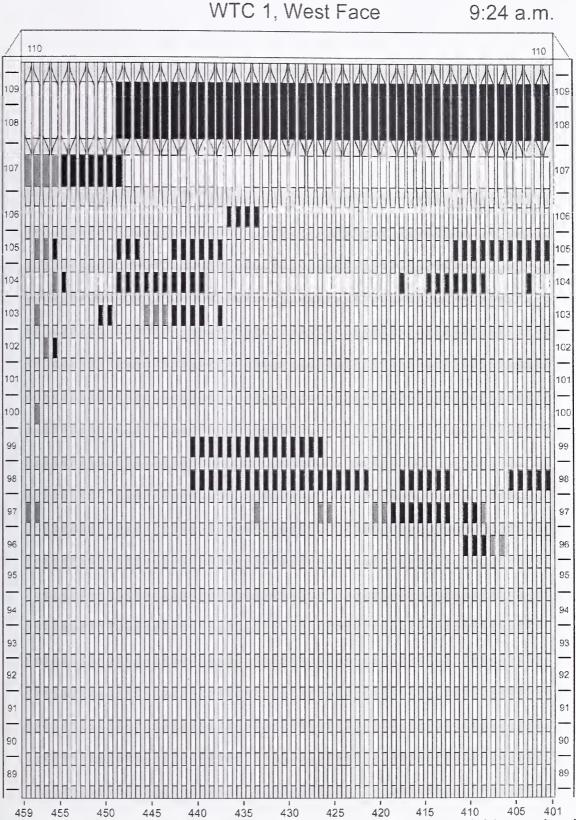
Figure F-32. Diagram of the west face of WTC 1 for floors 89 to 110 at 9:24 a.m. showing windows where smoke was observed and those that were hidden from view.

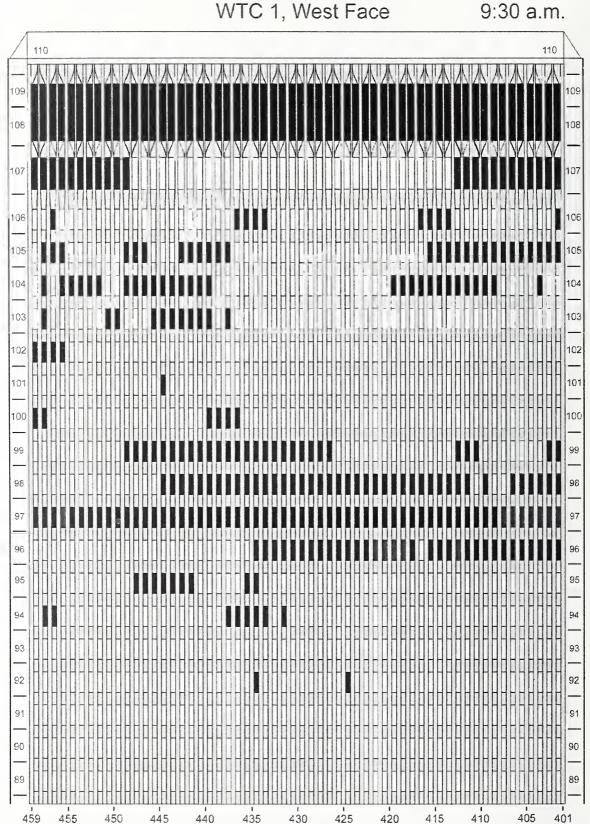
Figure F-33. Diagram of the west face of WTC 1 for floors 89 to 110 at 9:30 a.m. showing the condition of windows and locations of fires.

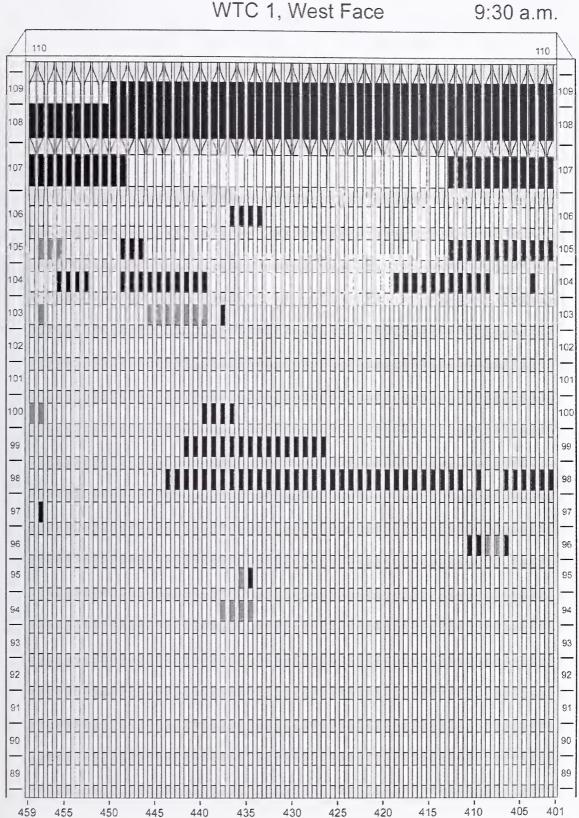
Figure F-34. Diagram of the west face of WTC 1 for floors 89 to 110 at 9:30 a.m. showing windows where smoke was observed and those that were hidden from view.

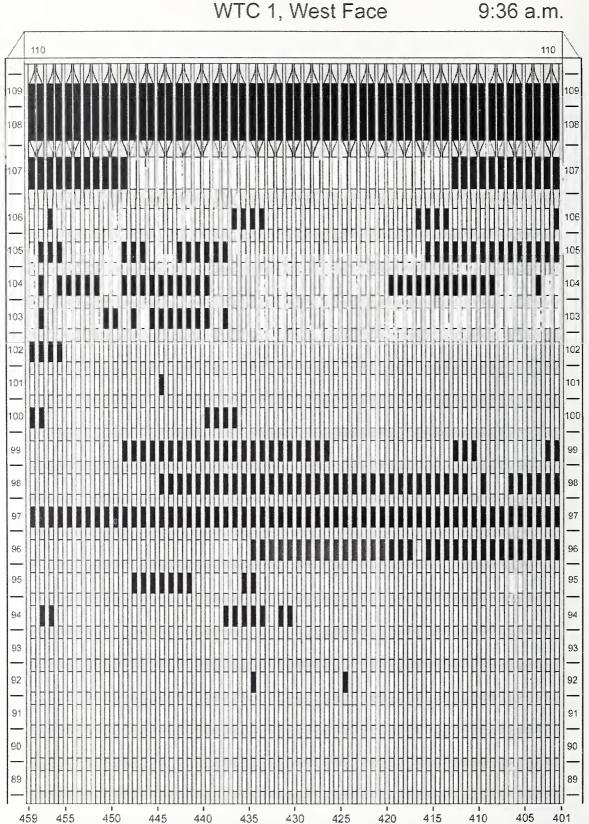
Figure F-35. Diagram of the west face of WTC 1 for floors 89 to 110 at 9:36 a.m. showing the condition of windows and locations of fires.

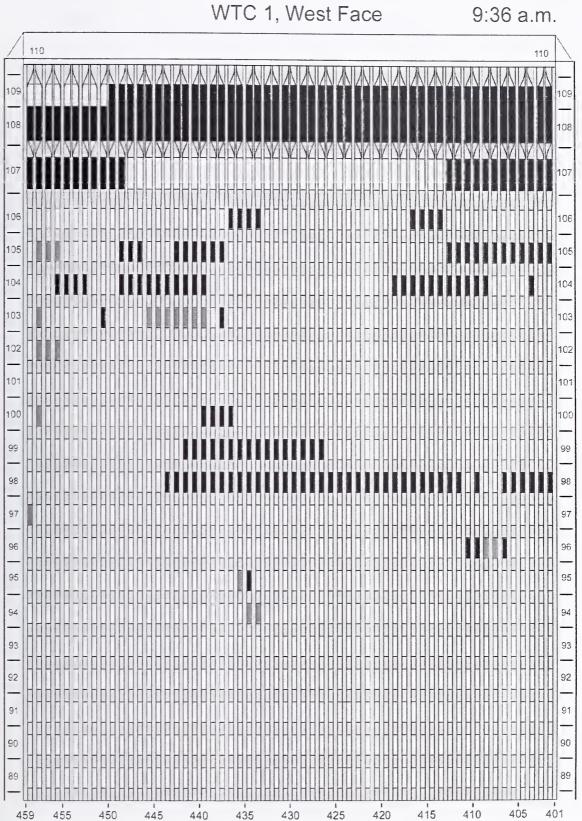
Figure F-36. Diagram of the west face of WTC 1 for floors 89 to 110 at 9:36 a.m. showing windows where smoke was observed and those that were hidden from view.

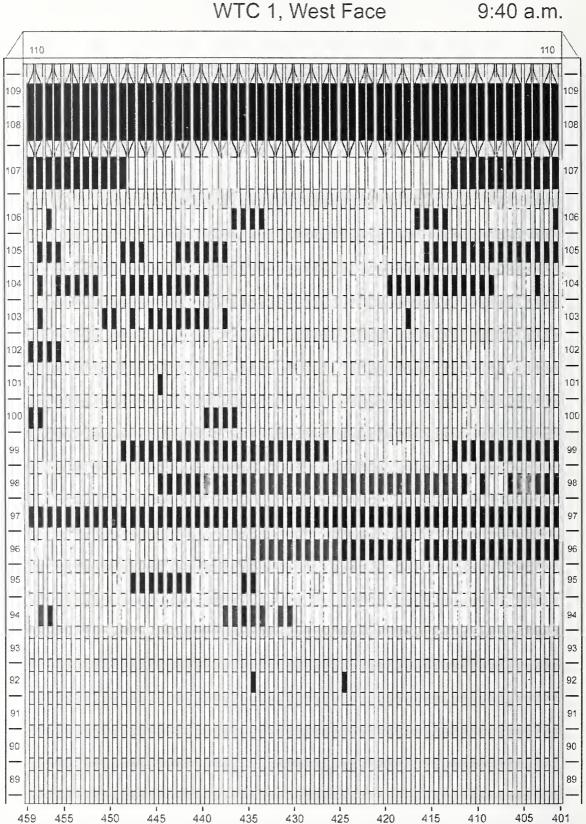
Figure F-37. Diagram of the west face of WTC 1 for floors 89 to 110 at 9:40 a.m. showing the condition of windows and locations of fires.

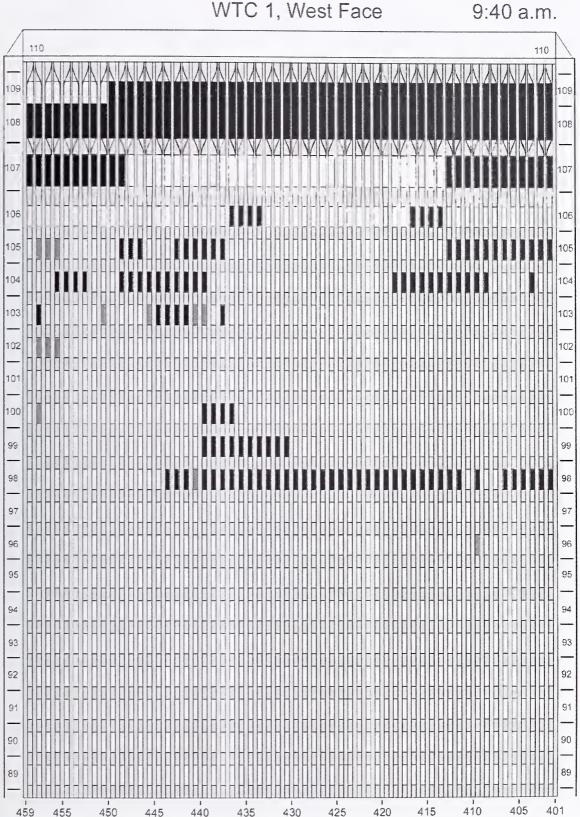
Figure F-38. Diagram of the west face of WTC 1 for floors 89 to 110 at 9:40 a.m. showing windows where smoke was observed and those that were hidden from view.

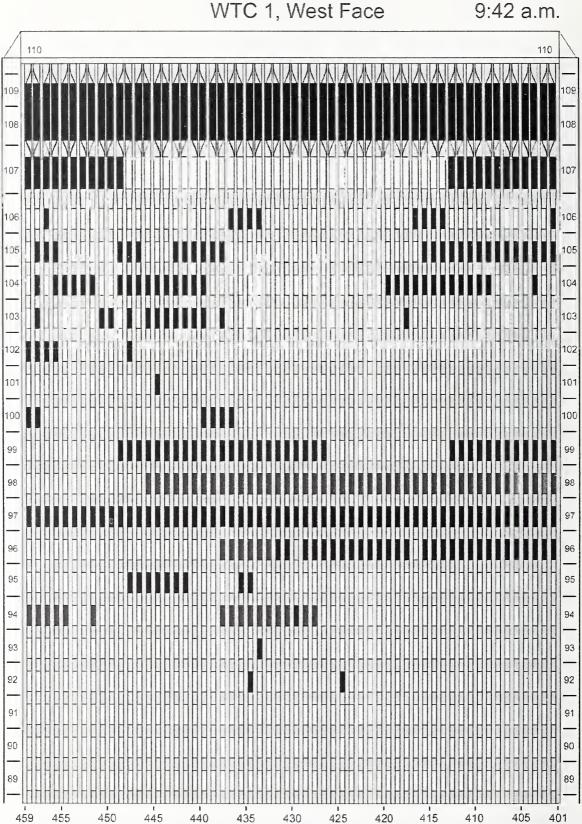
Figure F-39. Diagram of the west face of WTC 1 for floors 89 to 110 at 9:42 a.m. showing the condition of windows and locations of fires.
